Re: Morrow County  
OHD980569230  
(Former) HPM Plant #1  
Notice of Violation

On July 17, 2004, Ohio EPA conducted an investigation and review of the property located at 394 Lincoln Avenue in Mt. Gilead, Ohio. During this investigation and review, Ohio EPA was represented by Phil Farnlacher, Division of Solid & Infectious Waste Management and me. The current property owner, Mid-Ohio Sanitation & Recycling, was represented by Mr.

During the investigation and review, several tanks and containers of wastes and/or discarded materials were viewed and photographed. Below is a listing of some of these wastes or discarded materials and their locations. This listing is not all inclusive:

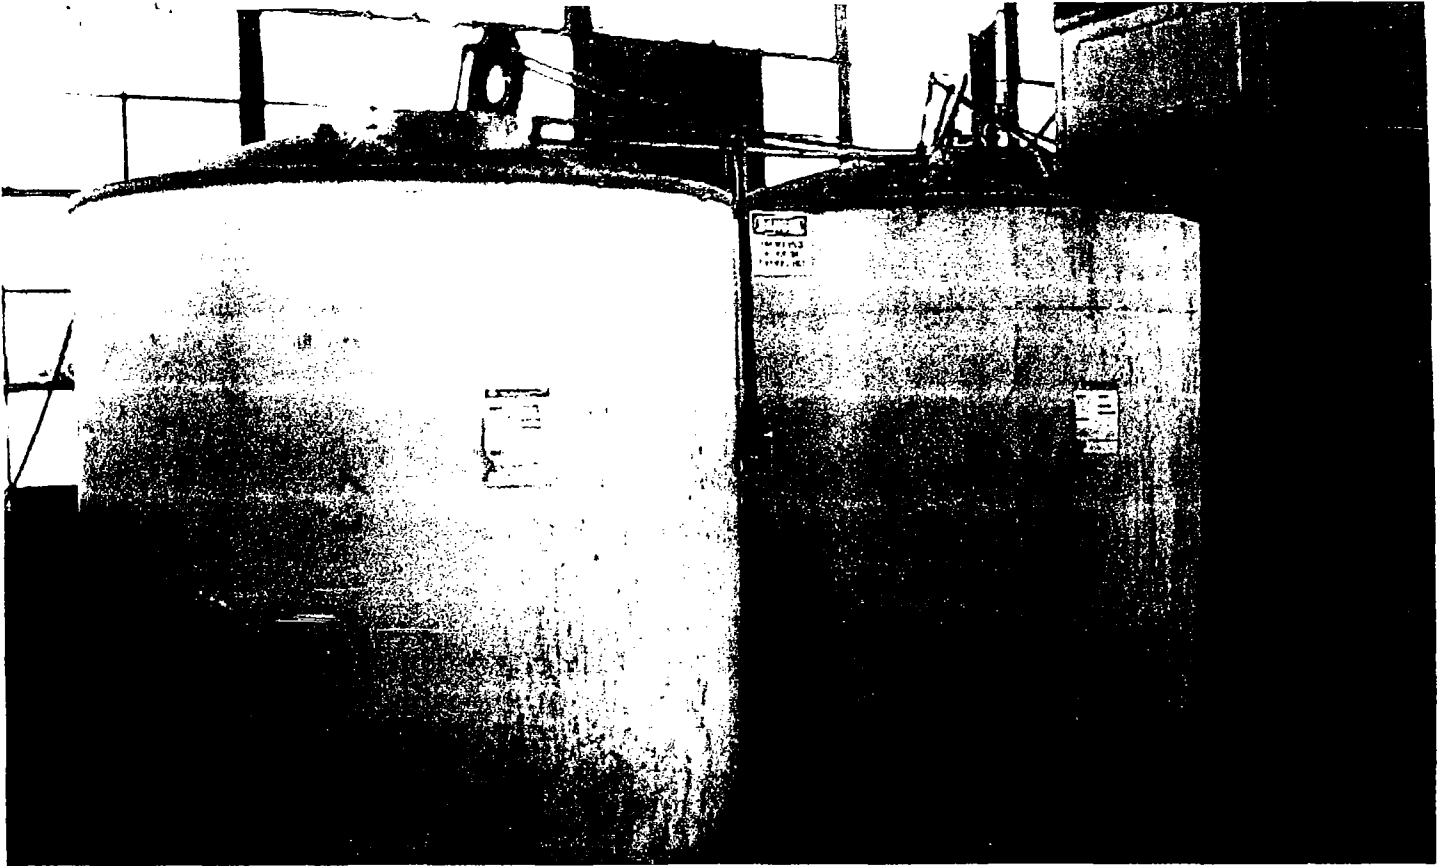
Former HPM Plant 1; 7-15-04; partially filled tank (1 @ ~1,000 gallons) located at the west end of the building near the overhead doors leading to the dock area. The tank is labeled HOCUT 797-E Coolant, Houghton International Inc. Adjacent tank appeared to be empty (NW).

All wastes and/or discarded materials must be immediately evaluated to determine if they are hazardous wastes. Once adequate characterization is completed, appropriate management and/or disposal must be conducted. Should any of these wastes and/or discarded materials be determined to be hazardous, additional hazardous waste management rules and/or violations could be applicable.

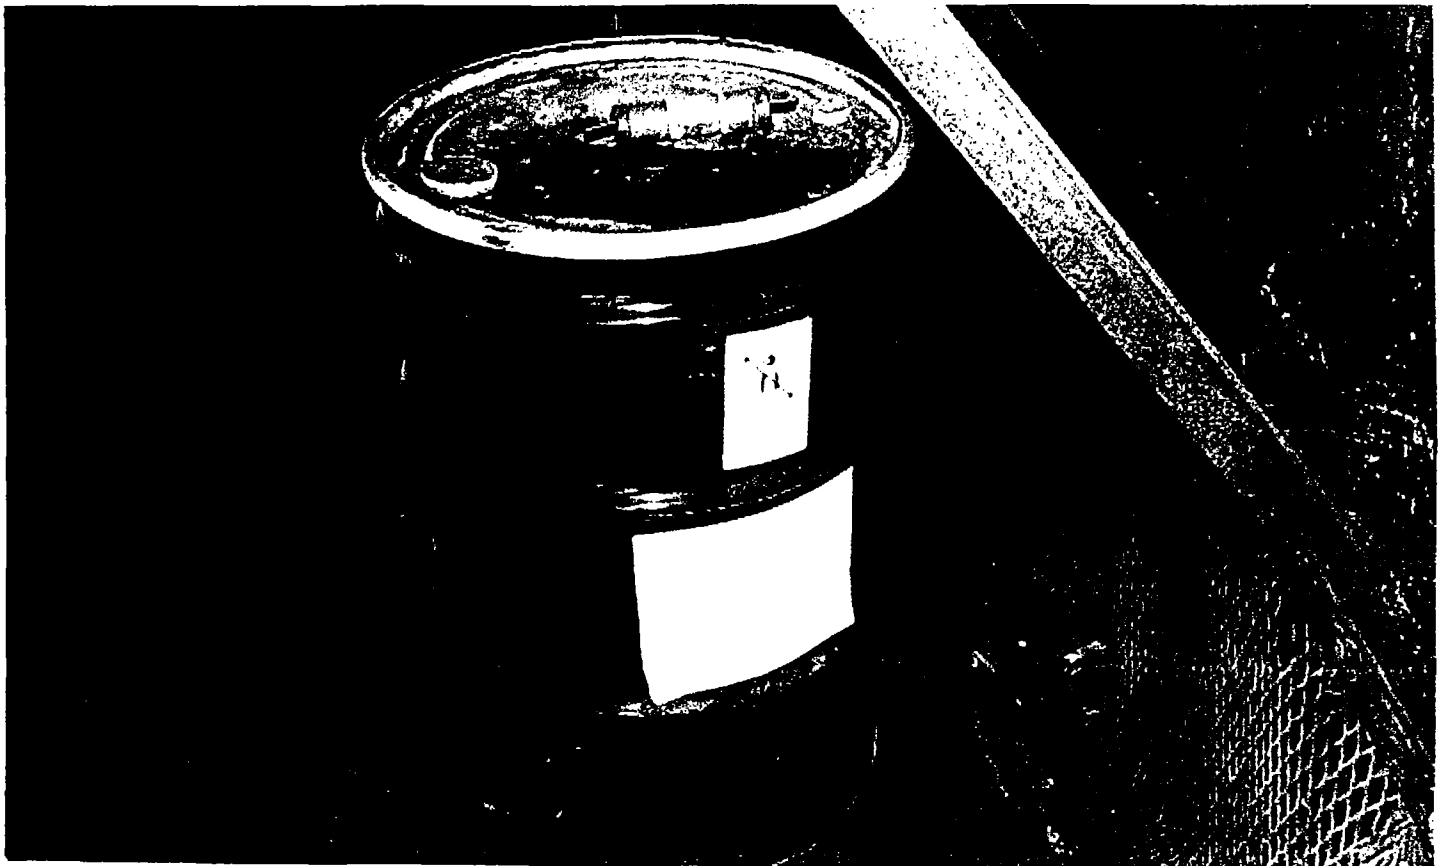
Former HPM Plant 1; 7-15-04; partially filled 55-gallon container located at west end of building near overhead door area. The container was labeled TC-267-C, TRU CHEM, Columbus, OH (SE).

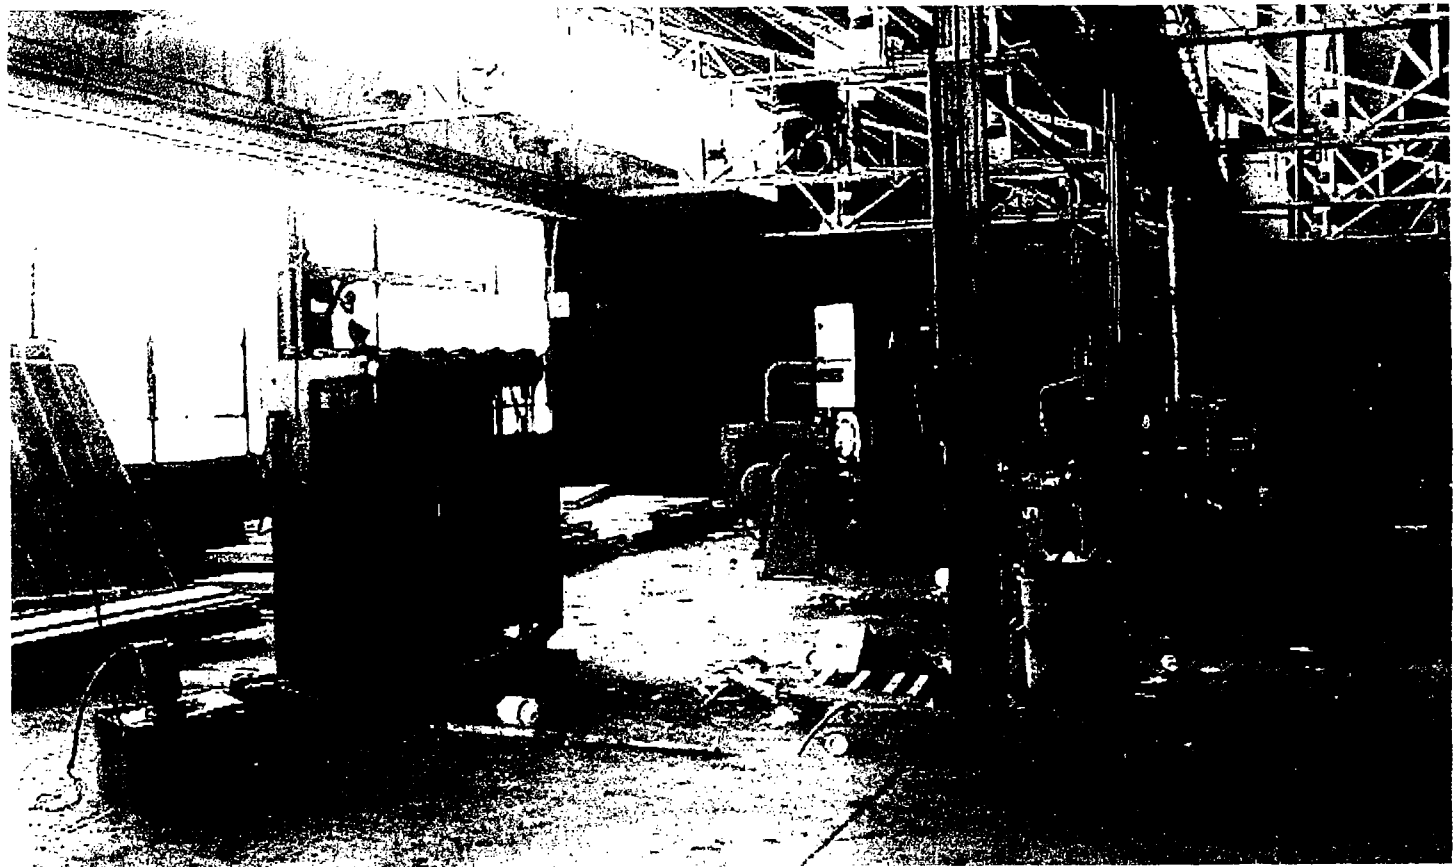
Former HPM Plant 1; 7-15-04; equipment and containers located on north side of west end of building, contents unknown (NE).

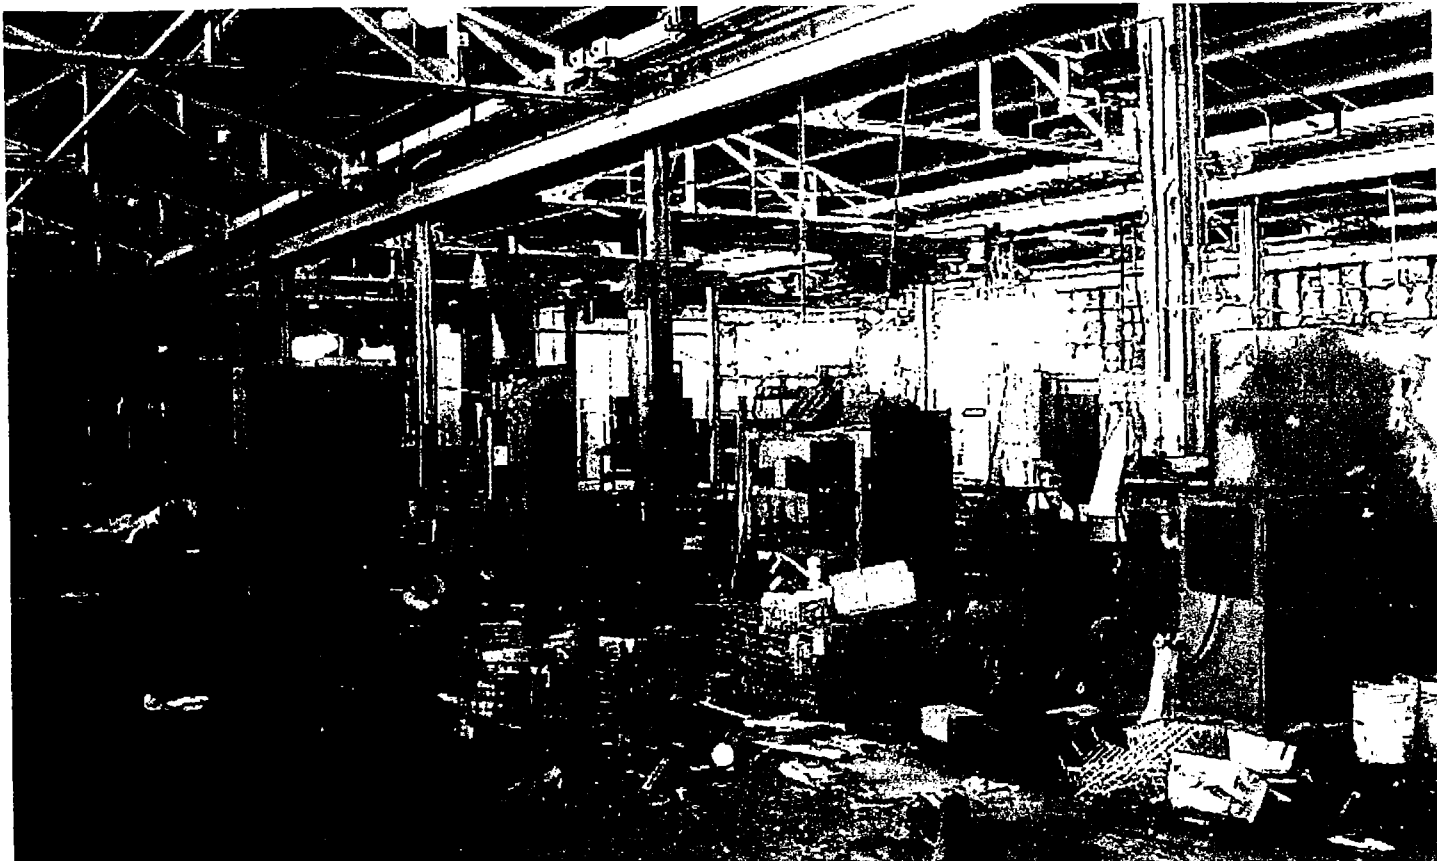
Former HPM Plant 1; 7-15-04; equipment and containers located on south side of the west end of the building, contents of equipment/containers unknown (SE).

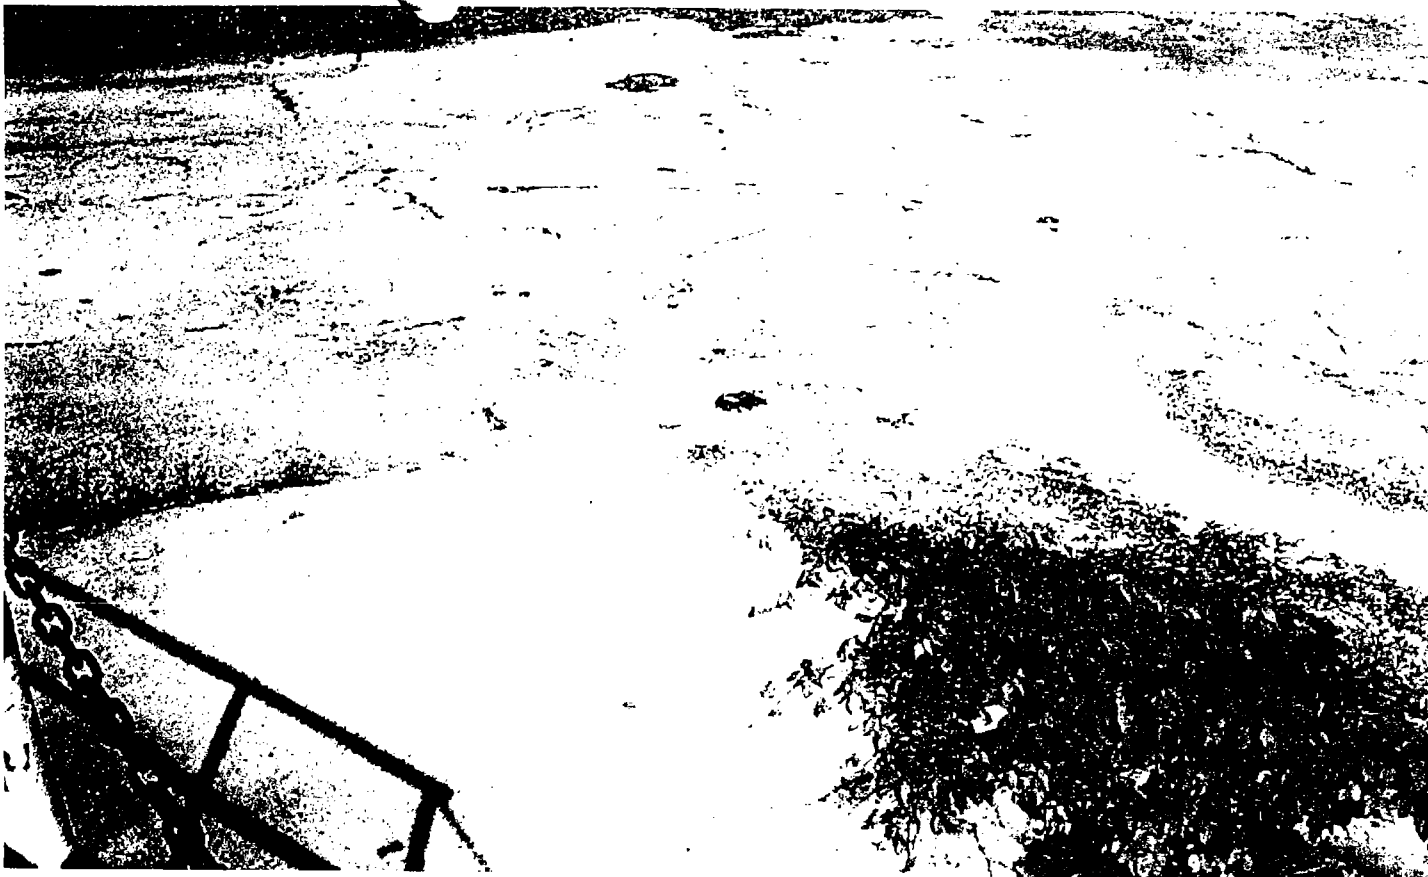
Former HPM Plant 1; 7-15-04; monitoring wells located near underground tank area (see well caps) outside the west end of the building near the dock area (NW).

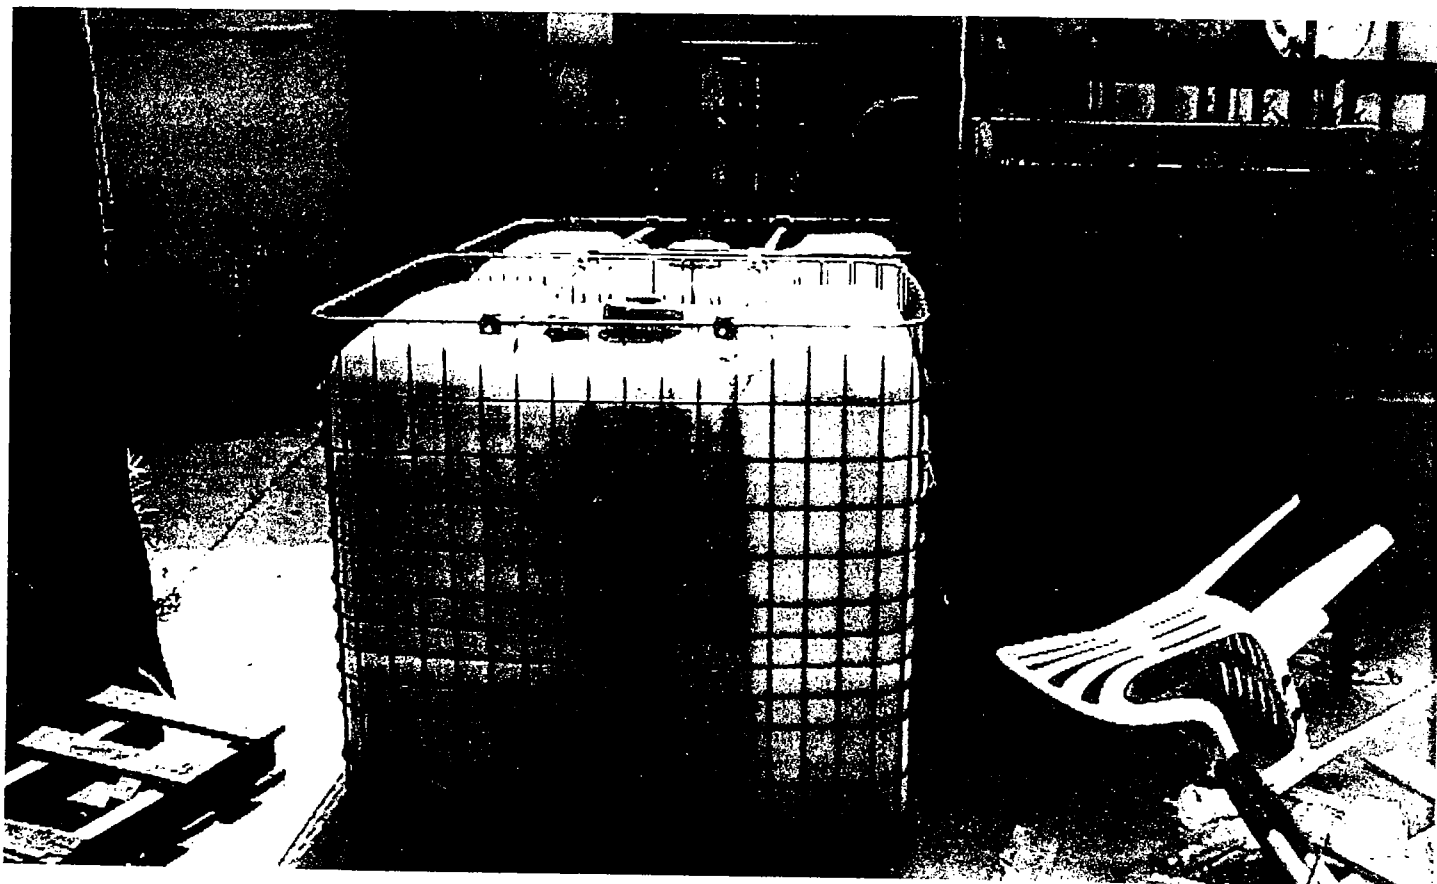
Former HPM Plant 1; 7-15-04; partially filled totes with unknown contents (2 @ ~300 gallons) located on dock area outside of west end of building (E).

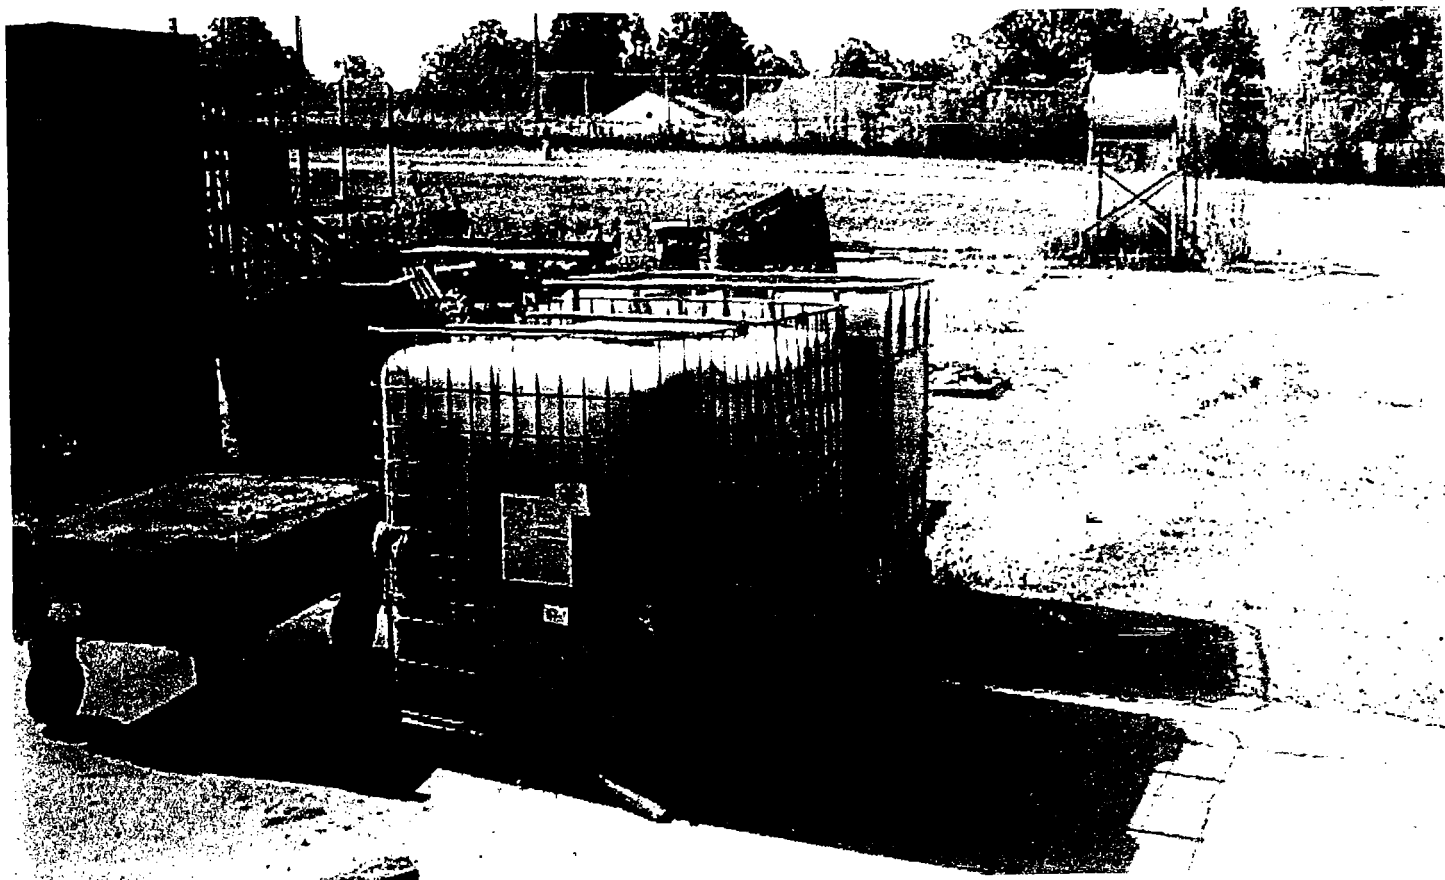
Former HPM Plant 1; 7-15-04; partially filled totes with contents unknown (2 @ ~300 gallons) located on dock area outside of the west end of the building. Fuel tank in upper right of photo was reportedly empty (S).

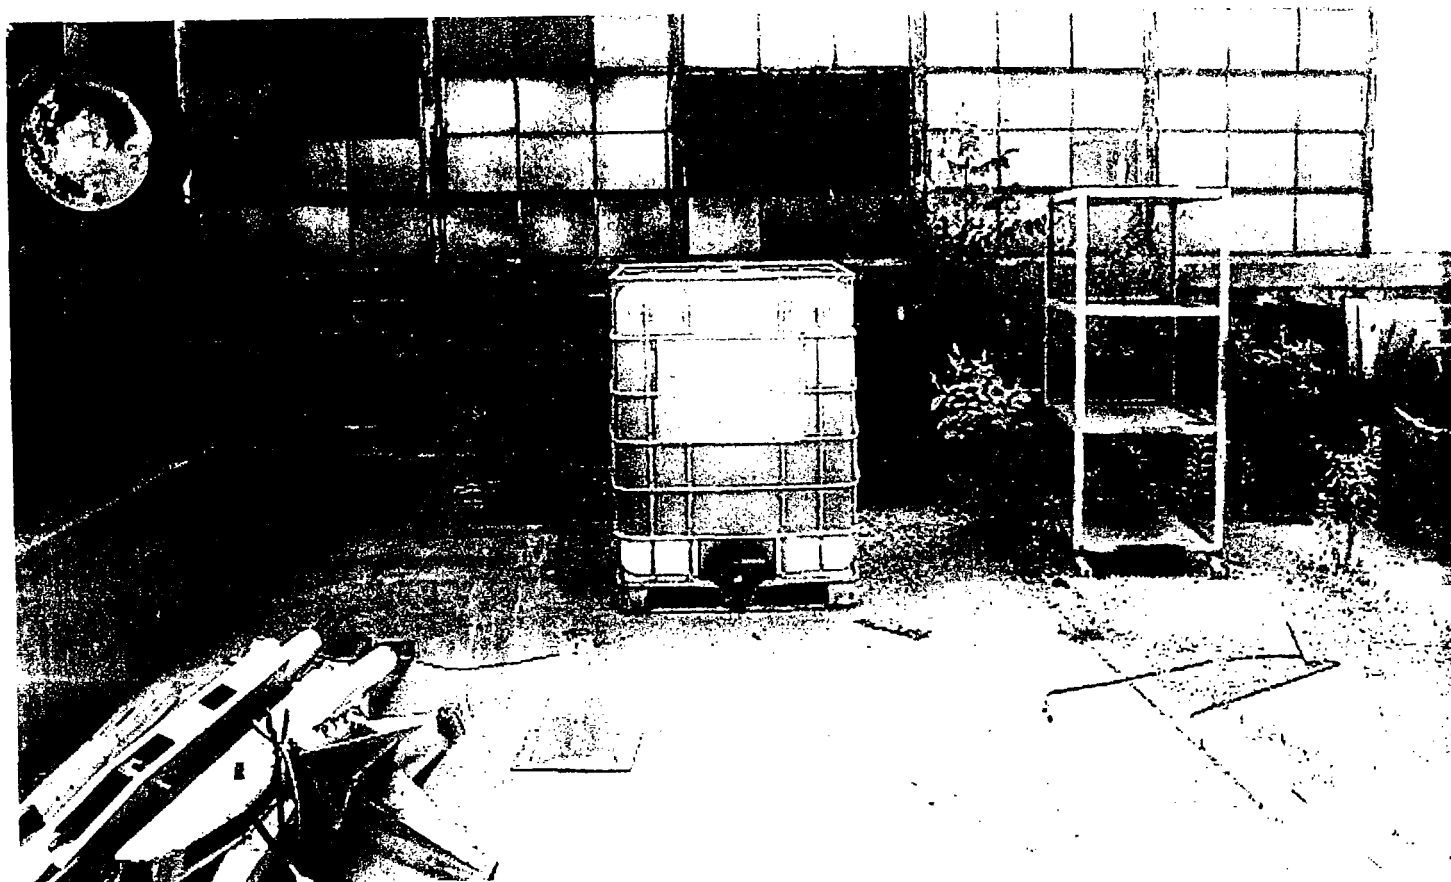
Former HPM Plant 1; 7-15-04; filled tote (1 @ ~300 gallons) with contents unknown located on dock area outside of the west end of the building (E).

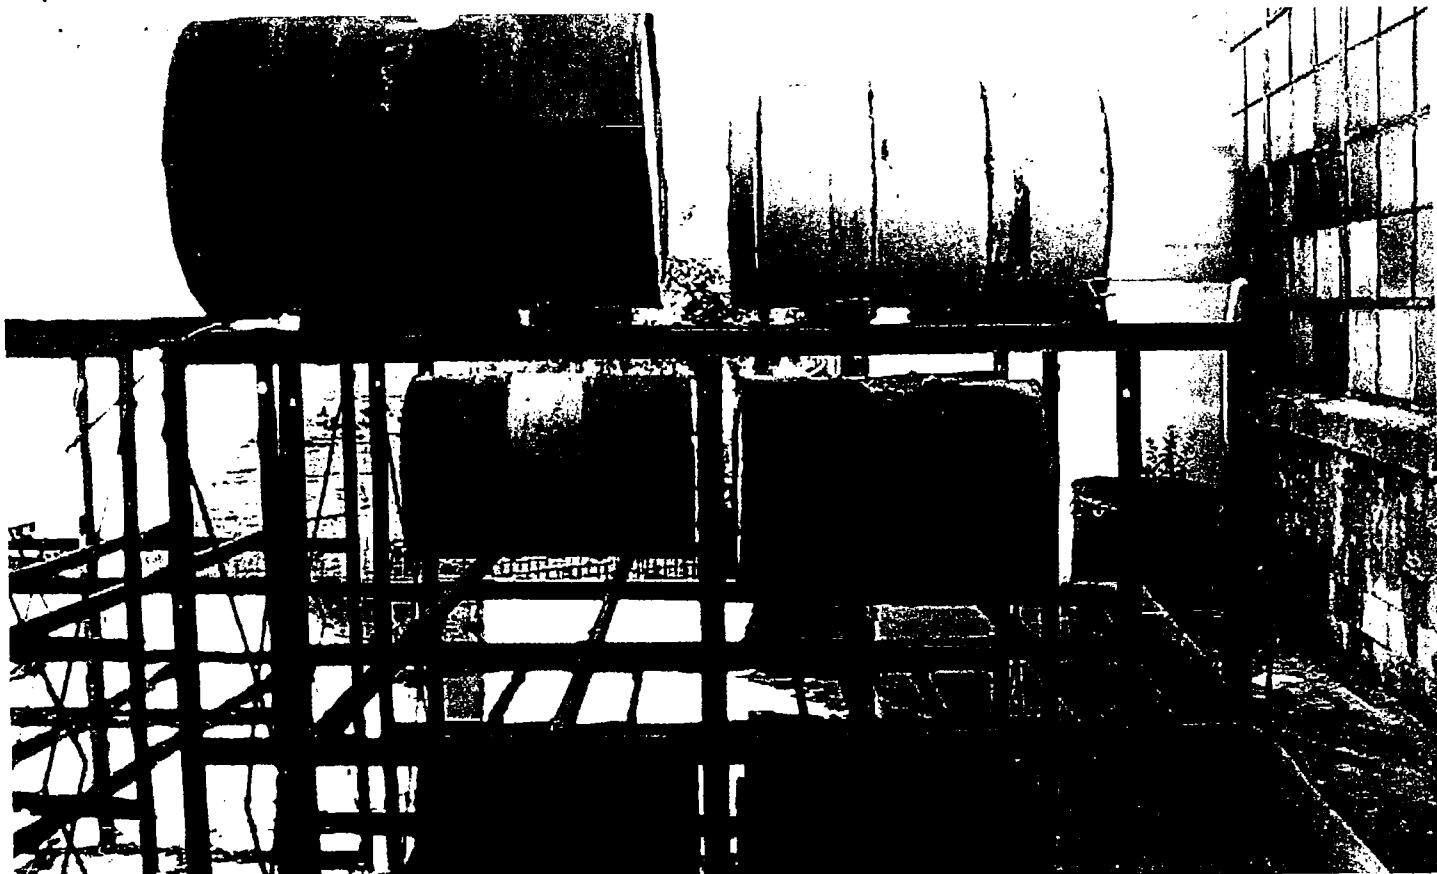
Former HPM Plant 1; 7-15-04; 55-gallon container holding rack area with concrete dike located on dock area outside of the west end of the building, contents of containers unknown, diked area filled with water with visible sheen (N).

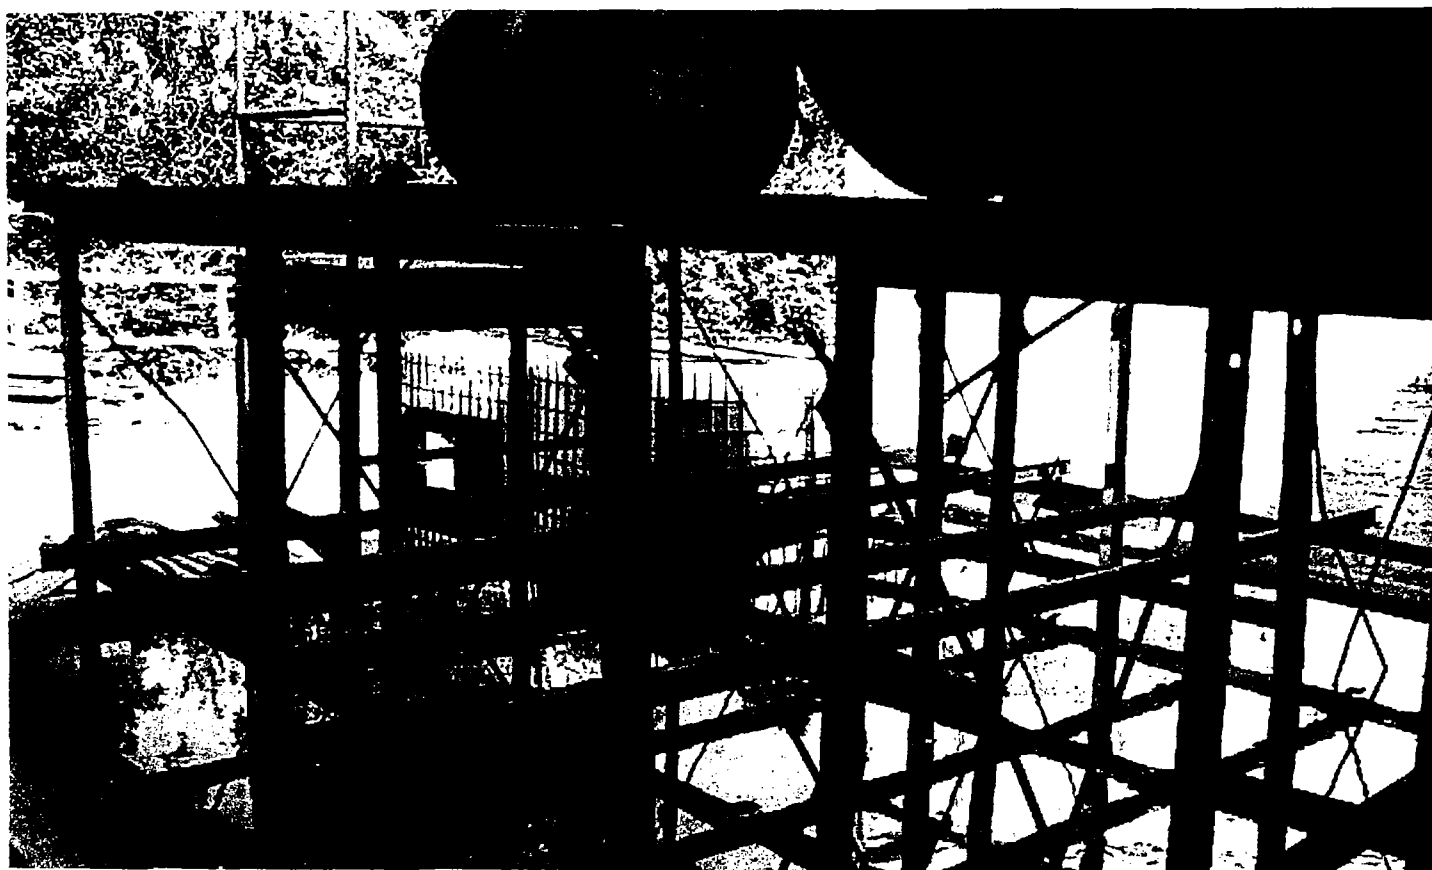
Former HPM Plant 1; 7-15-04; 55-gallon container rack area located on dock outside of the west end of the building, sheen is visible in photo on water in dike area (NW).

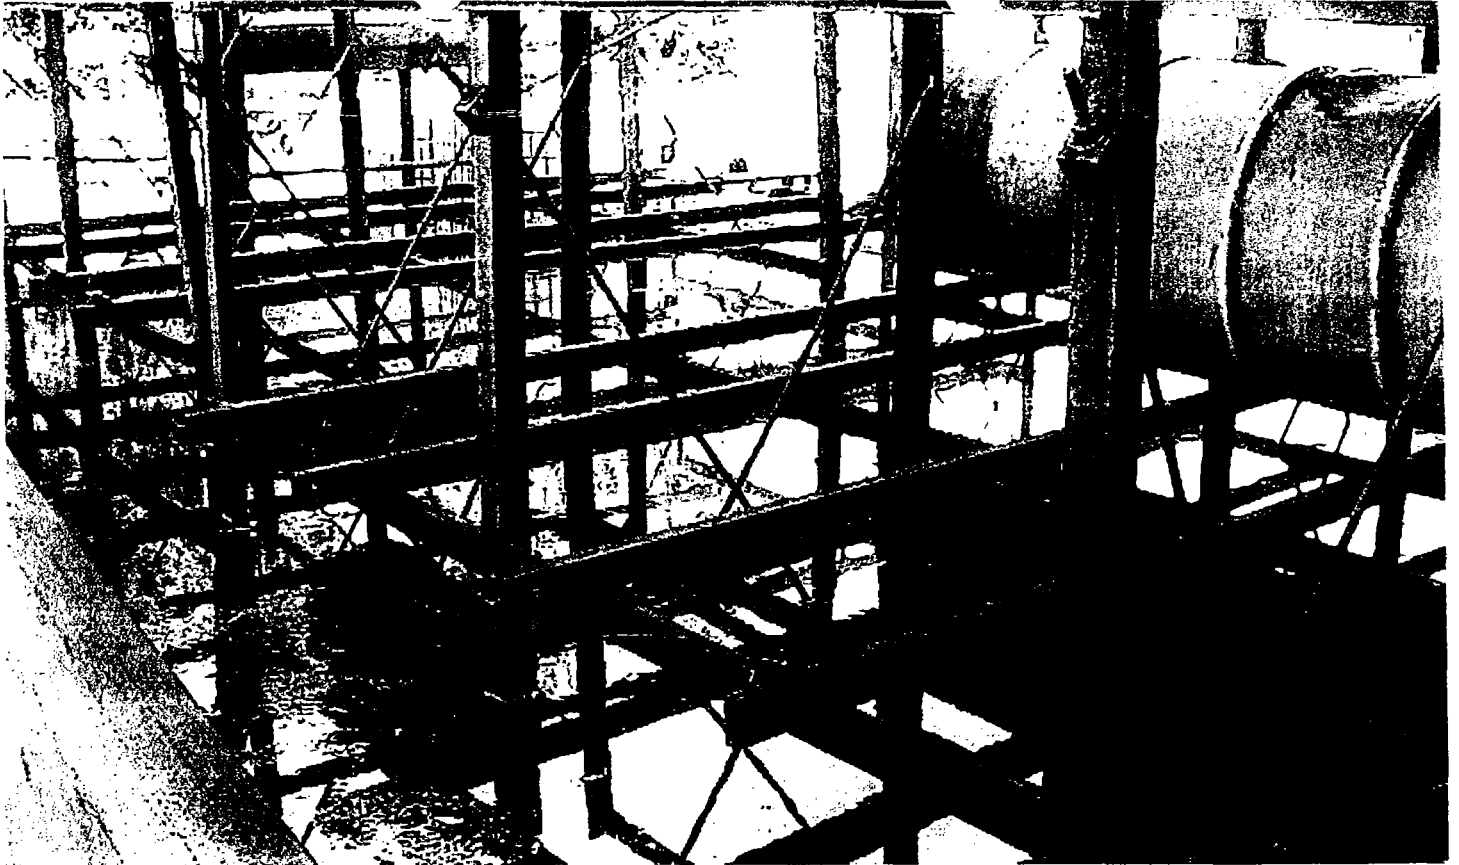
Former HPM Plant 1; 7-15-04; 55-gallon container rack area on dock outside west end of the building, diked area is filled with water with oily sheen visible (NW).

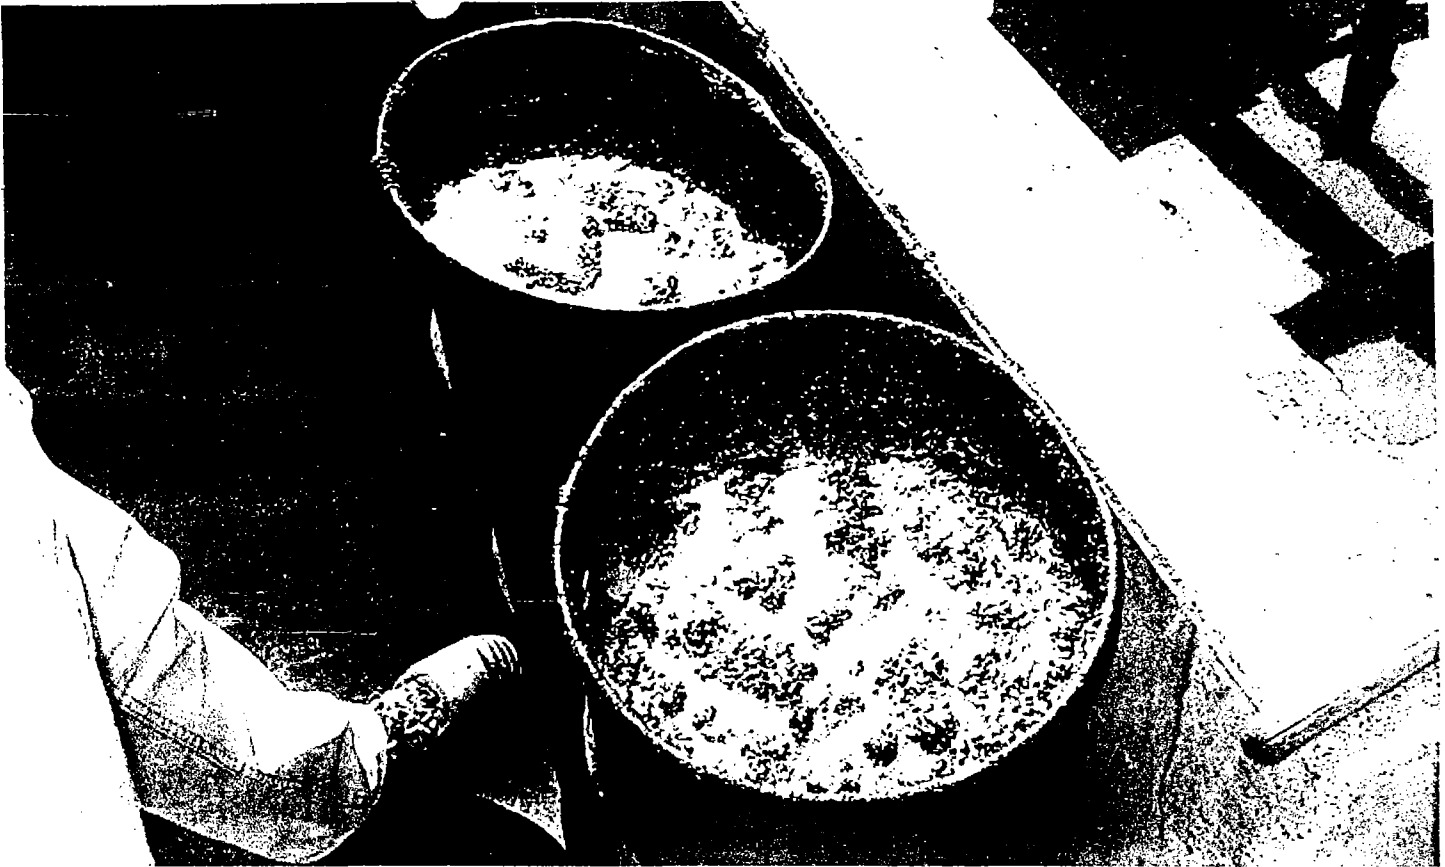
Former HPM Plant 1; 7-15-04; open 55-gallon containers of waste (contents unknown) located on dock area outside west end of building adjacent to the diked rack area (S).

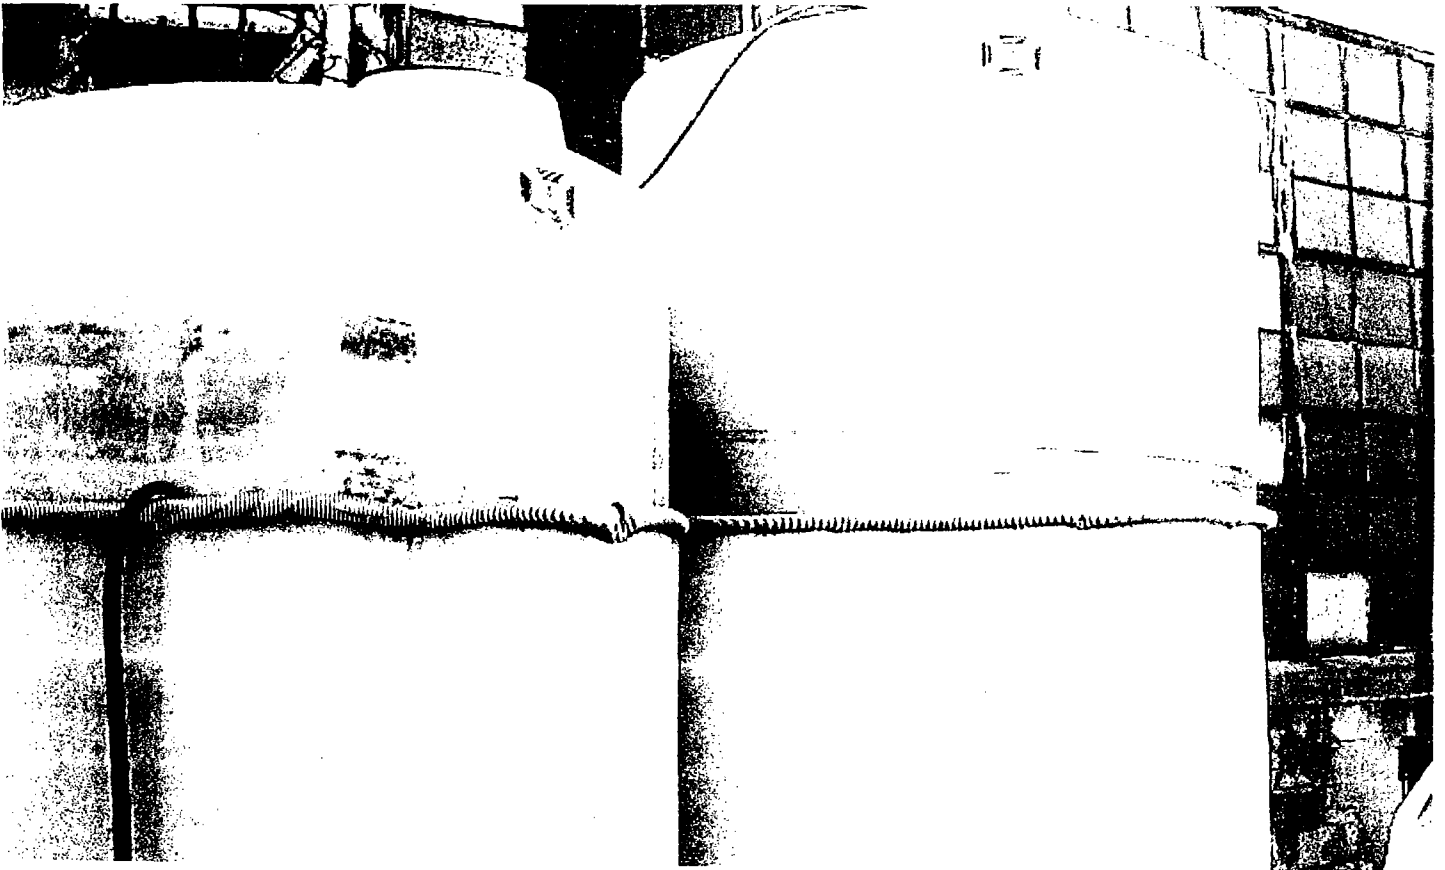
Former HPM Plant 1; 7-15-04; partially filled tanks (2 @ ~1,300 gallons) with contents unknown located on dock area outside west end of building (E).

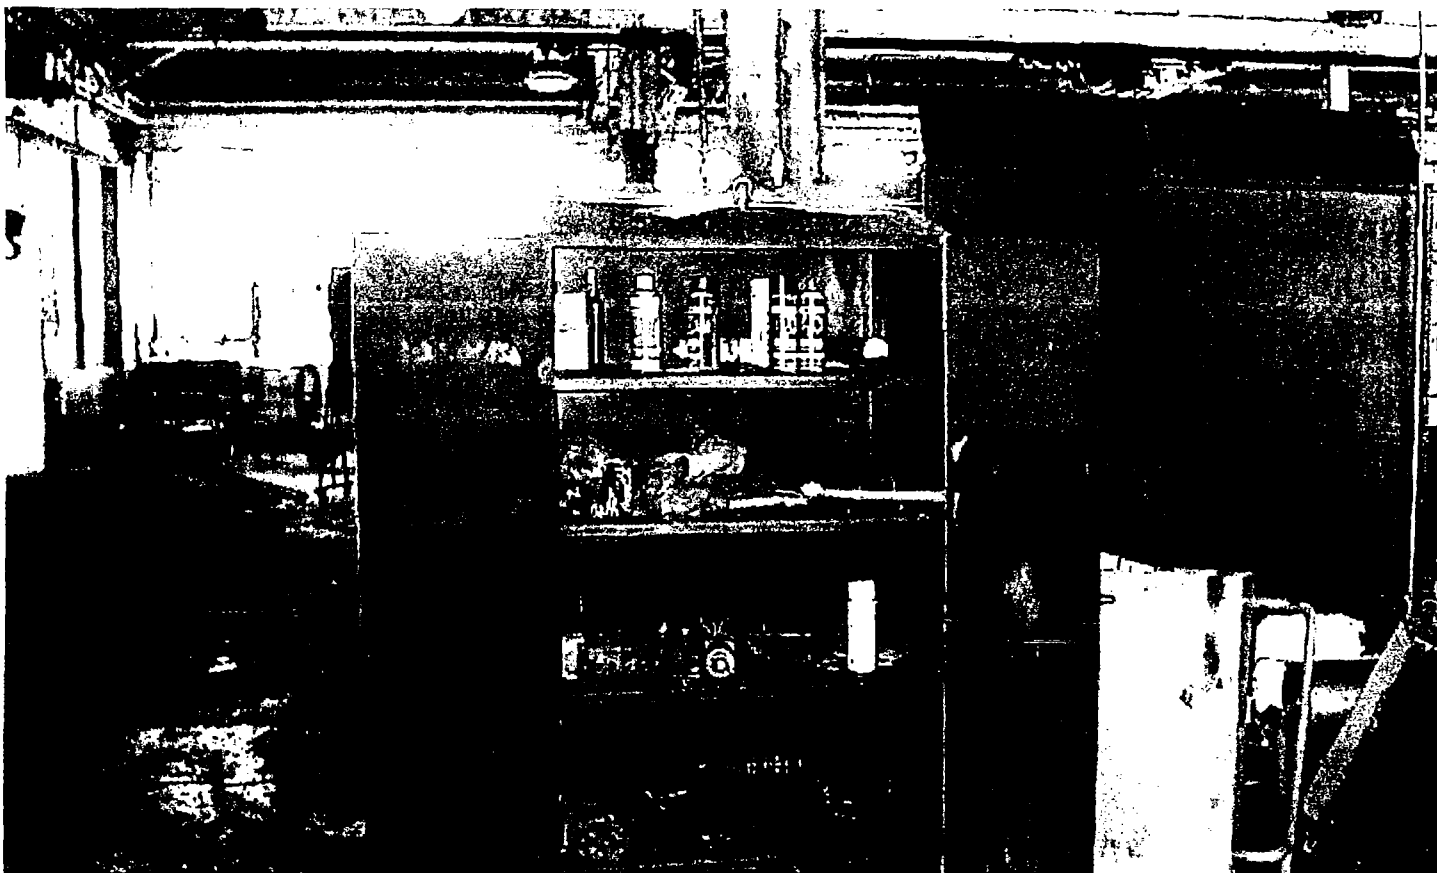
Former HPM Plant 1; 7-15-04; partially used products/containers located in cabinet on south side of building in the western portion (S).

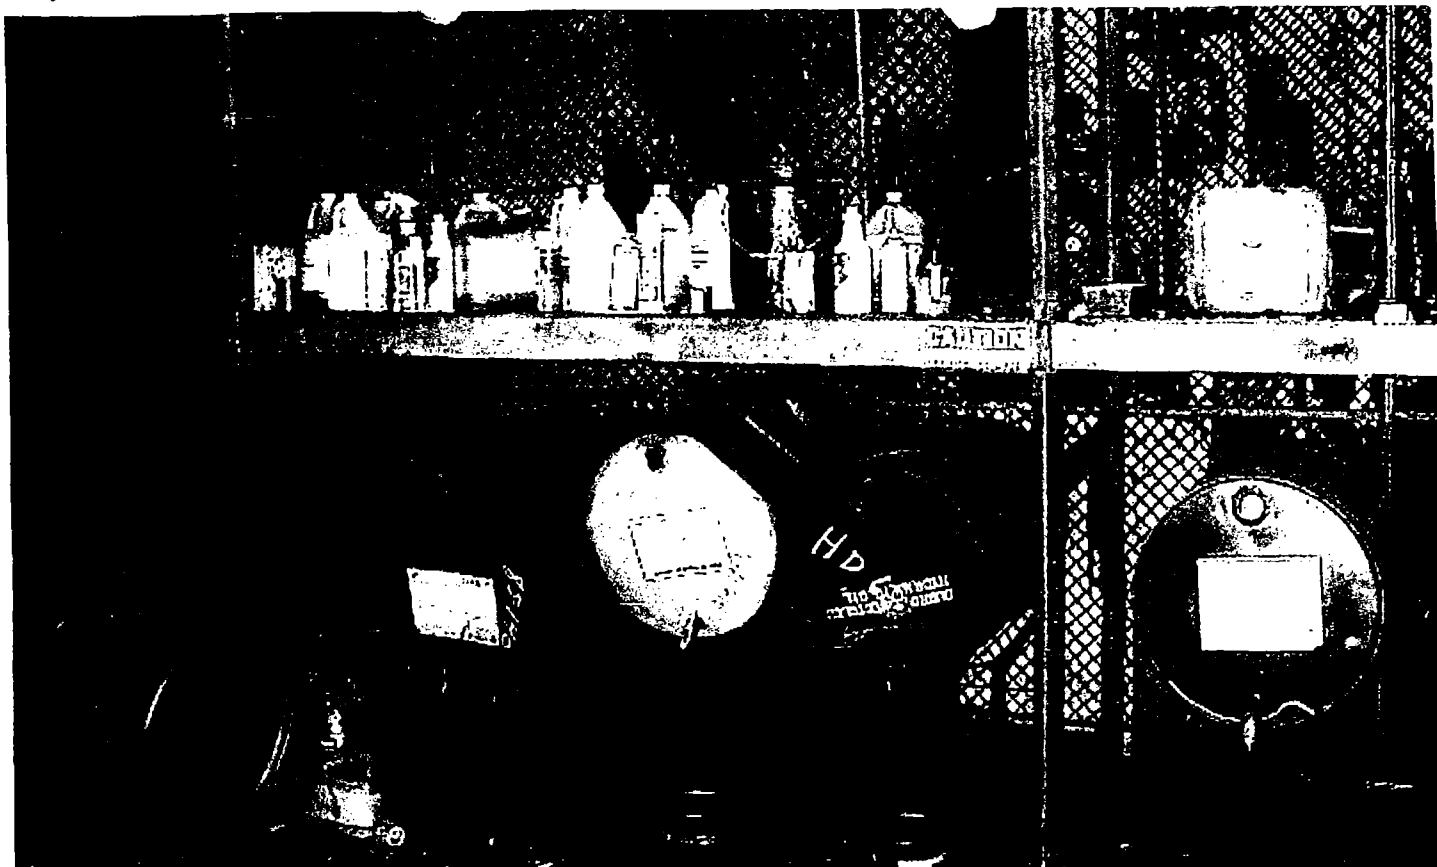
Former HPM Plant 1; 7-15-04; various partially filled containers, mostly of unknown contents, in holding rack located in middle portion of building (S).

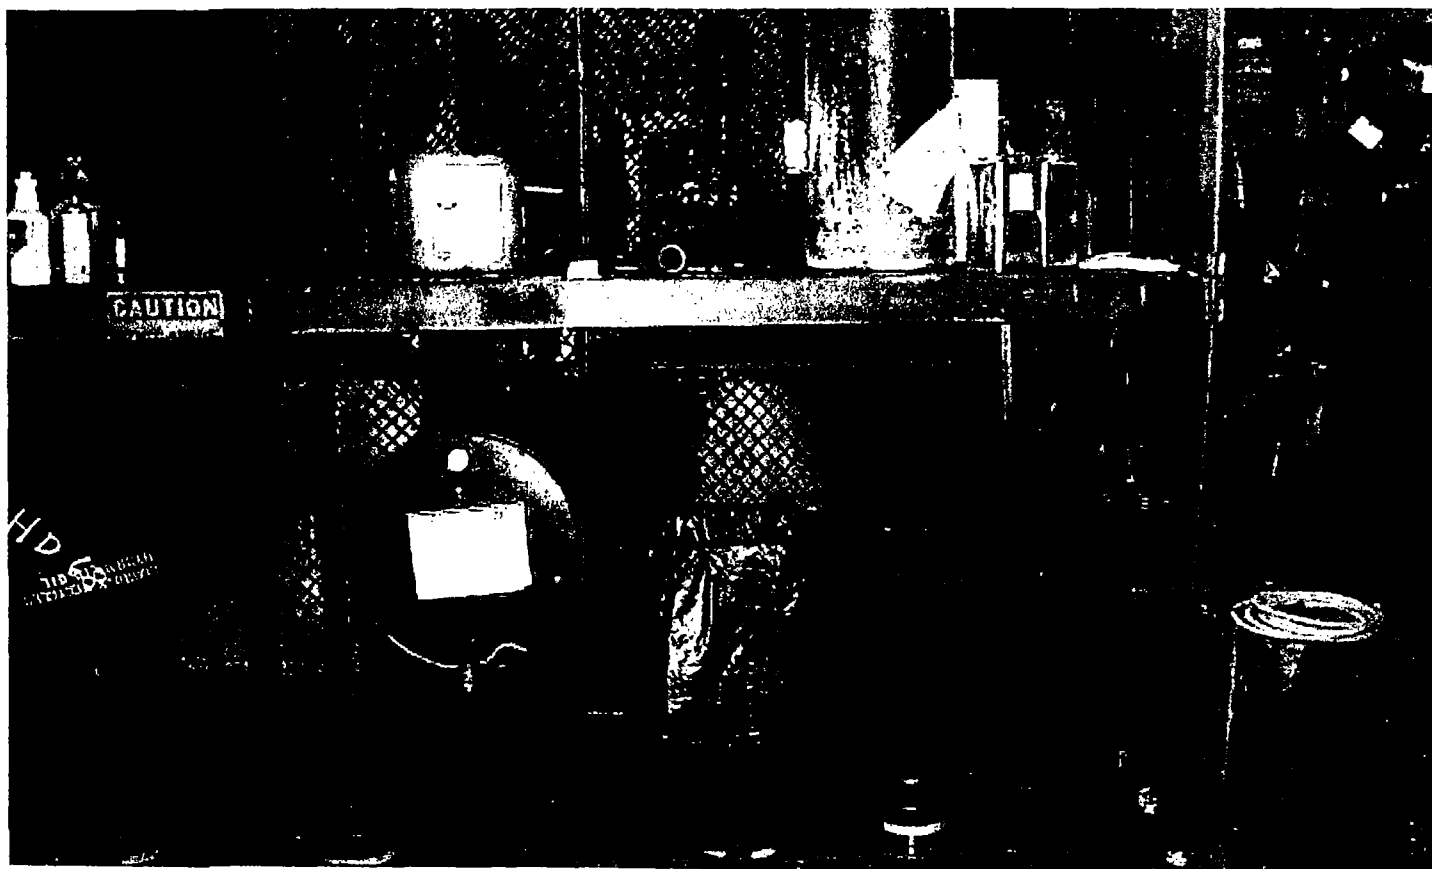
Former HPM Plant 1; 7-15-04; various partially filled containers, with unknown contents, in holding rack located in middle of building (S).

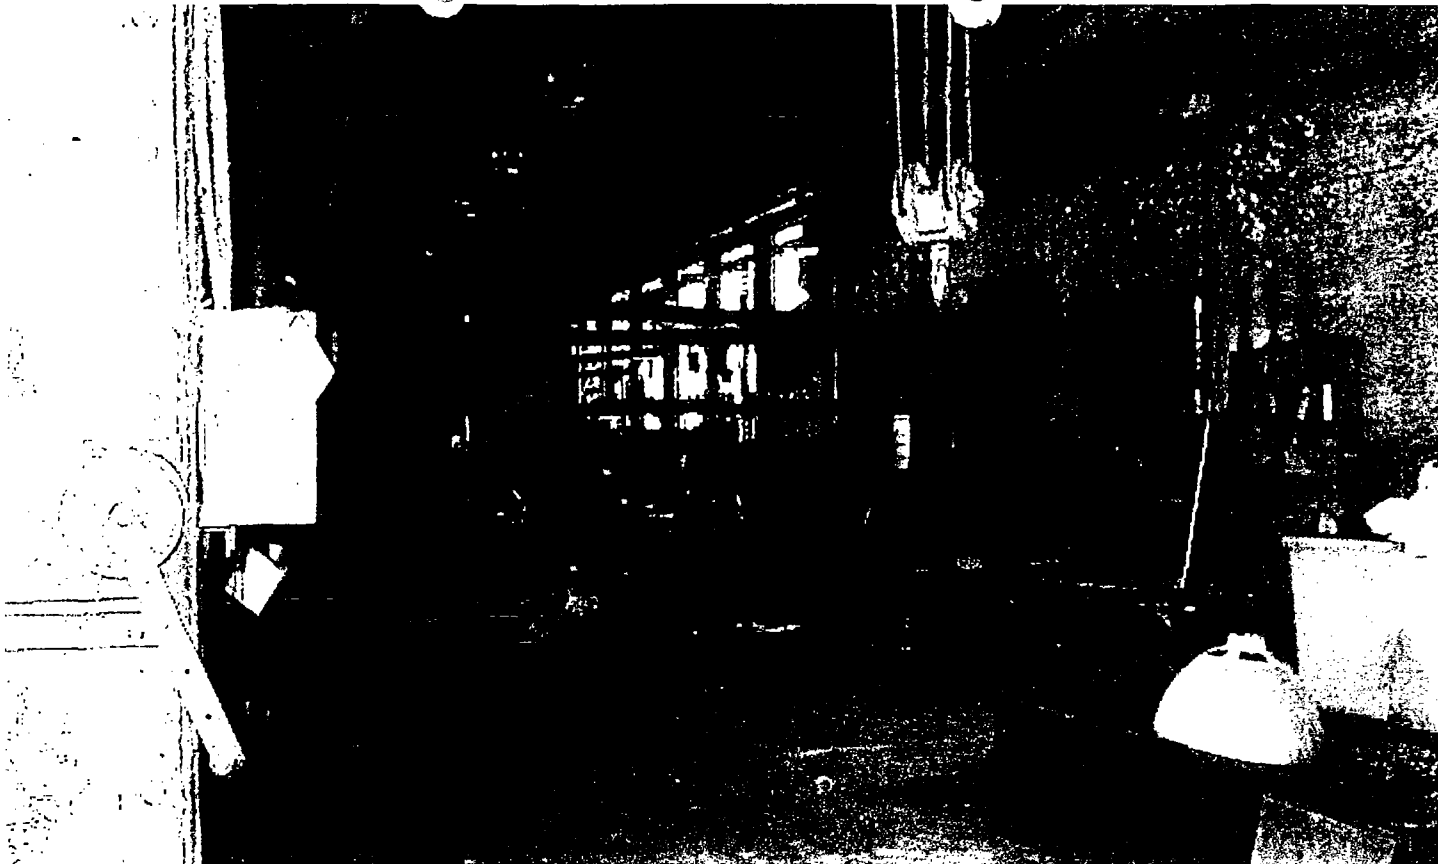
Former HPM Plant 1; 7-15-04; various equipment located on south side of middle area of building, equipment contents unknown (SE).
